Audi A3 8L Dash Display Dead Pixel Repair

Intro:

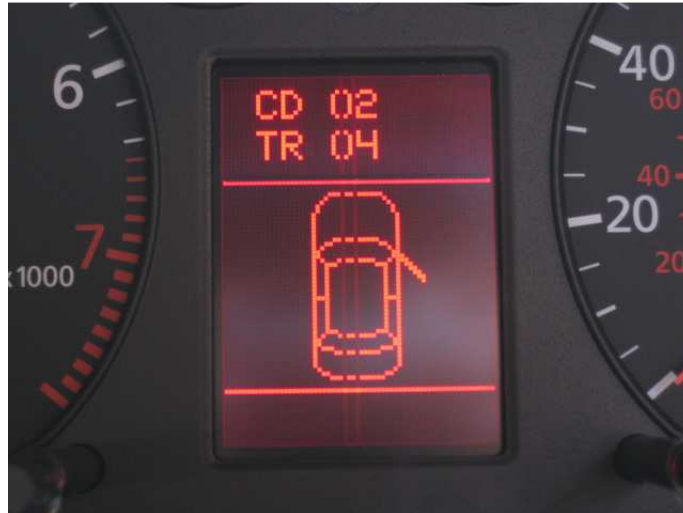
The photo below is showing you what I wanted to repair, as you can see there are 2 distinct lines of dead pixels.

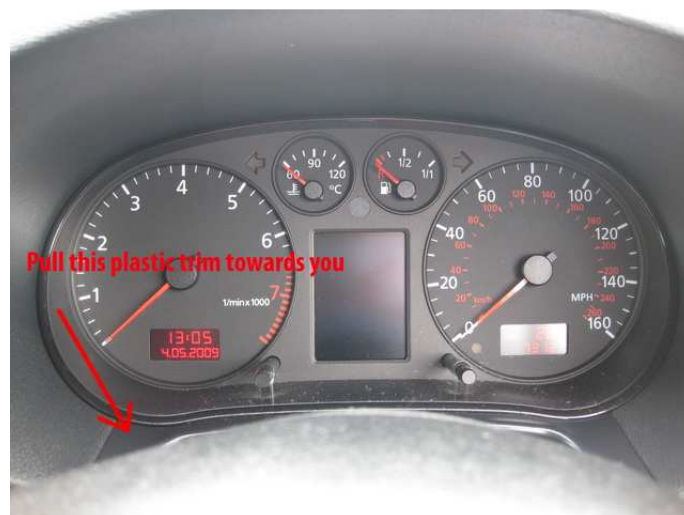
Begin by lowering the steering wheel's position to allow more room to work, do this using the handle on the underside of the steering wheel column. Then pull the plastic trim that runs below the odometer clocks, it's not screwed in at all it just comes towards you.

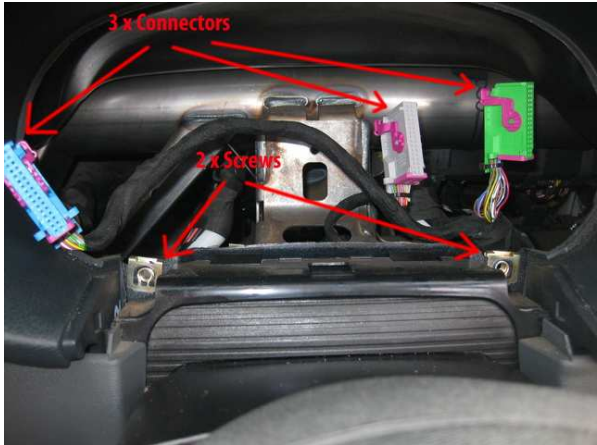
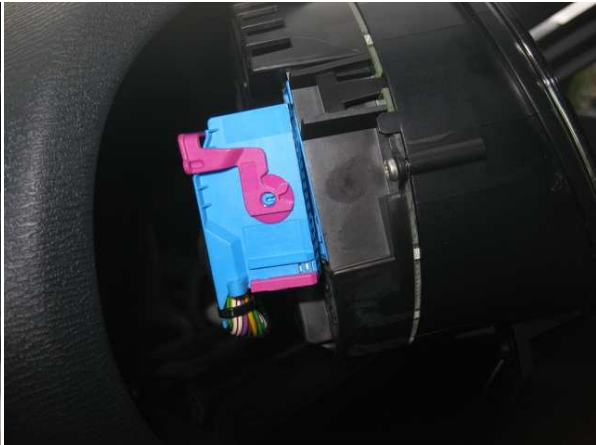
Once removed it will reveal 2 cross head screws which need to be taken out. Then the odometer will pull out allowing you to reach behind and disconnect the 3 connectors that are attached. The connectors have handles that flip over then the connector comes out.

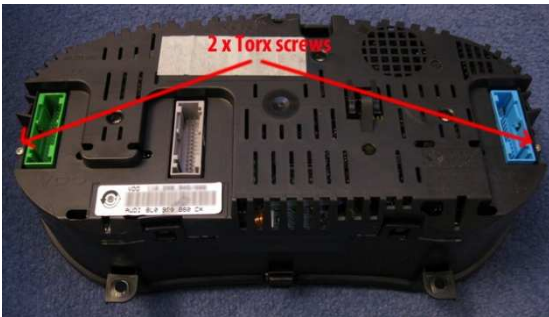
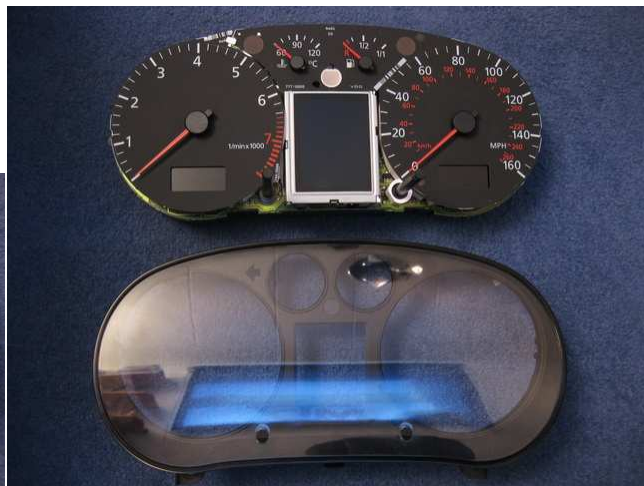
At the back of the clocks there are 2 Torx screws which need to come out, the front will then lift off.

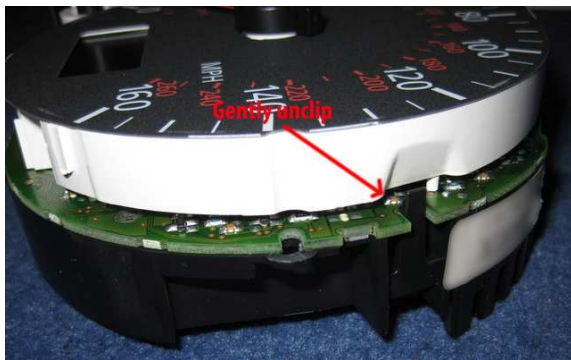
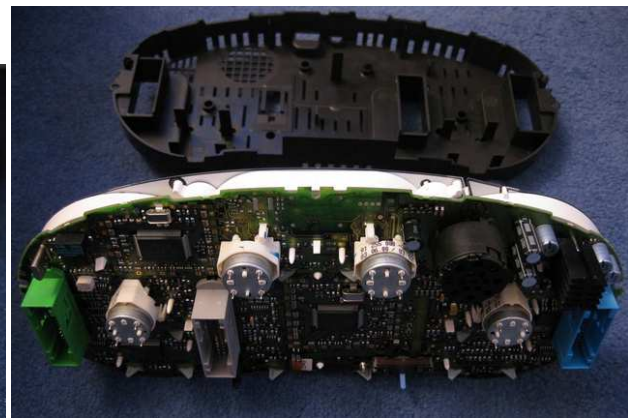
To remove the backing plastic there are 2 clips (one either side), then the back plastic will come off.

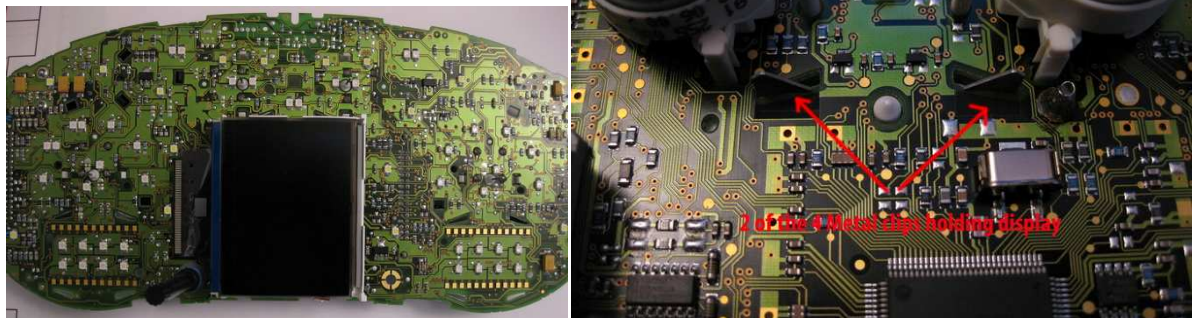
The dials, needles and plastics need to come off the front leaving only the LCD display on the front of the circuit board. I photographed the needles positions before I removed them as a reference for refitting. The needles just need to be twisted and pulled off, the dial face then will twist and unhook from the centre. The white plastic that it all sits on has a few clips at the back and the 2 small LCD's will need to have the metal clips untwisted too.

Above you can see the odometer with the needles and dials removed, the LCD display does have a metal frame which holds it down, I pictured 2 of them but there are 2 at the top and 2 at the bottom. At the rear the metal needs to be twisted so that the metal frame will pull off from the front. When you are removing the frame take care because there are 2 plastic strips which are under the LCD display (make sure not to lose them). Once removed you can see the LCD panel and now proceed to trying to fix it.

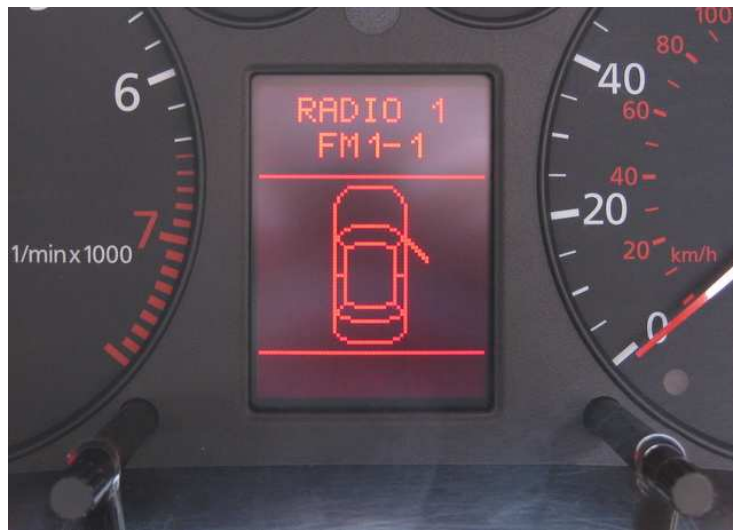
Here it is finished.

NOTE: This is the same LCD repaired and not replaced.

After all is done I placed everything back together, used the reference photos to return the dials back to the zero points and then refitted it in the vehicle. The needles seemed to not always reset to the same place when they have been turned so it takes a few attempts to make sure it is back in the correct place.
